## MOLD ASSESSMENT REPORT

10363 Bridge St  
White Springs, FL 32096

Town of White Springs

06/11/2024

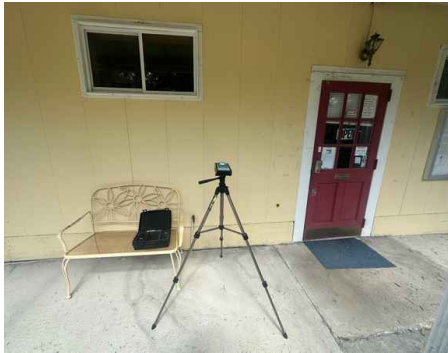
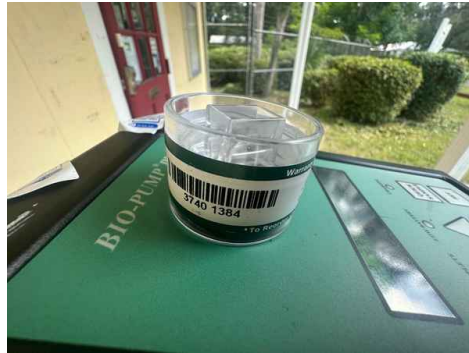
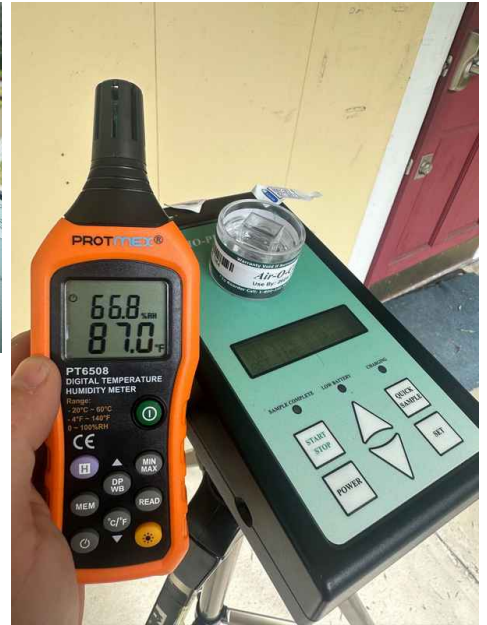
**Location: Sample 1**

Air, Exterior Control

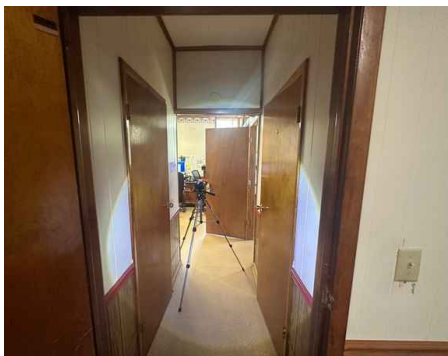
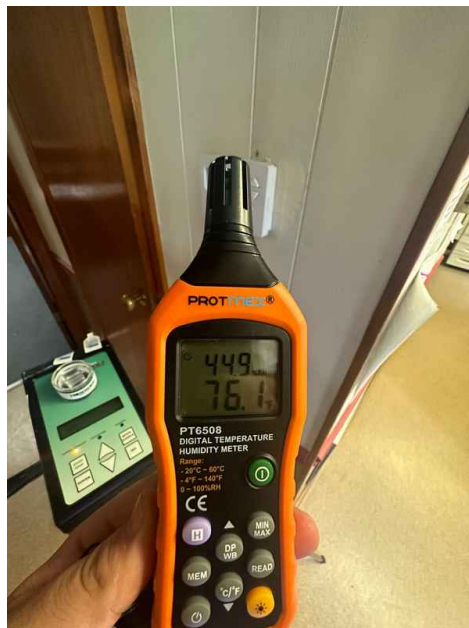
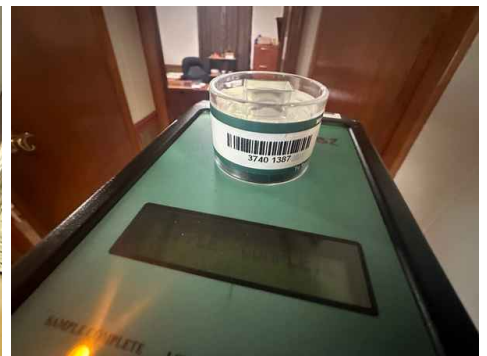
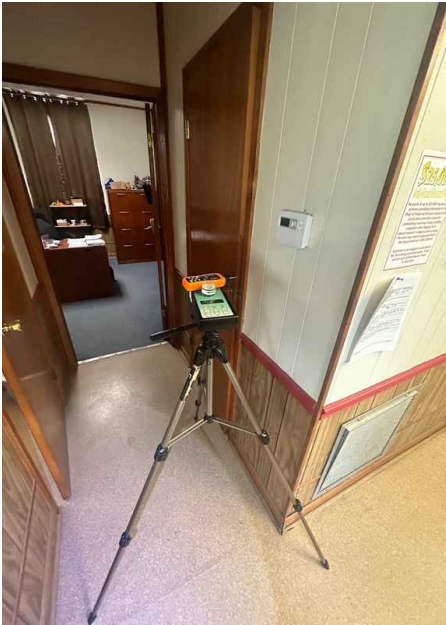
**Location: Sample 2**

Air, Entry

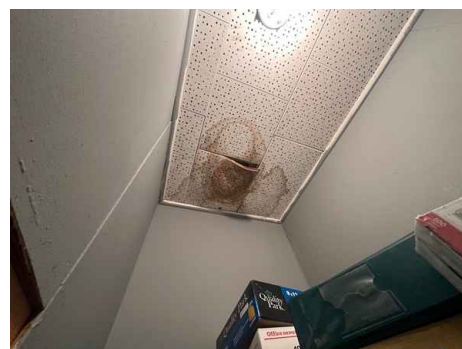
### Contributing Factors/Findings: Evidence of previous moisture event - roof leaks

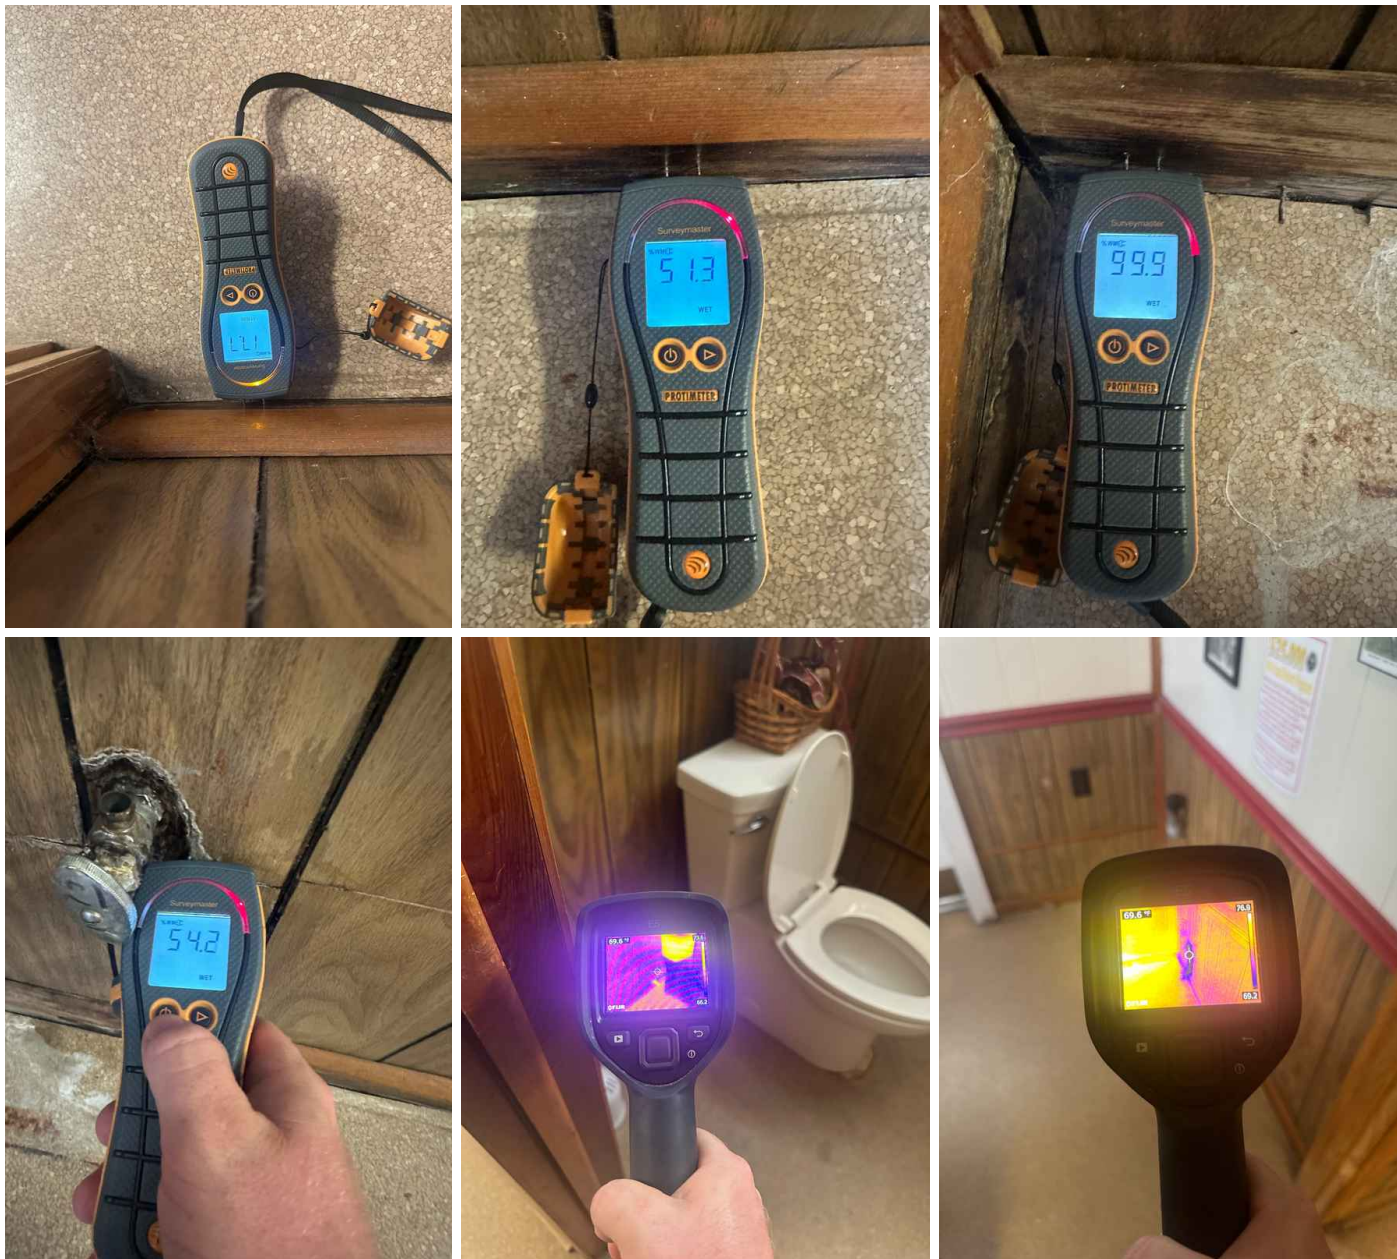
**Contributing Factors/Findings: Elevated Moisture Content at Area of Concern**

Moisture content readings at surface materials indicated elevated and saturated conditions in multiple locations at area of concern.

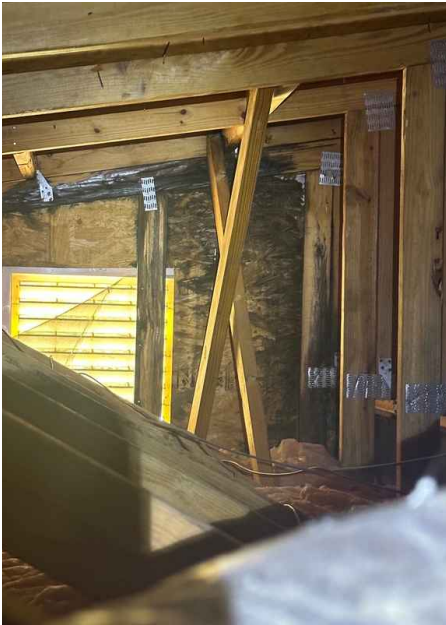
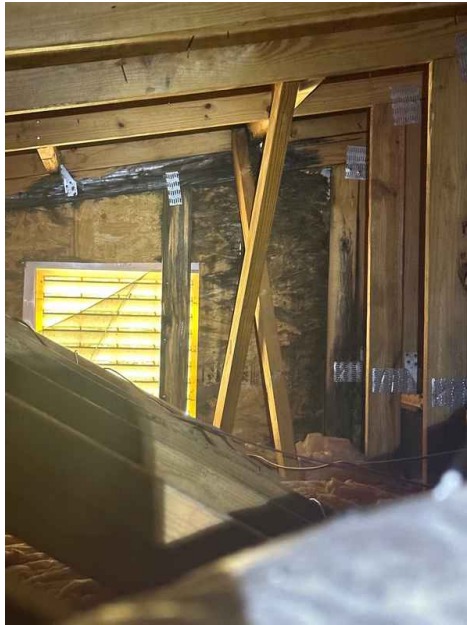
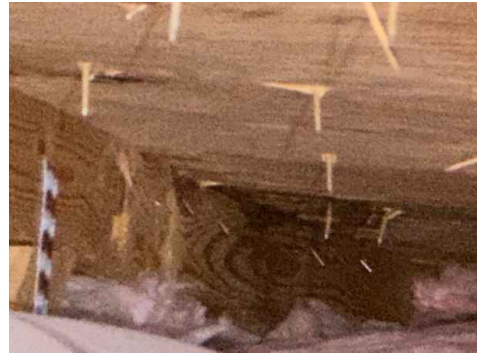
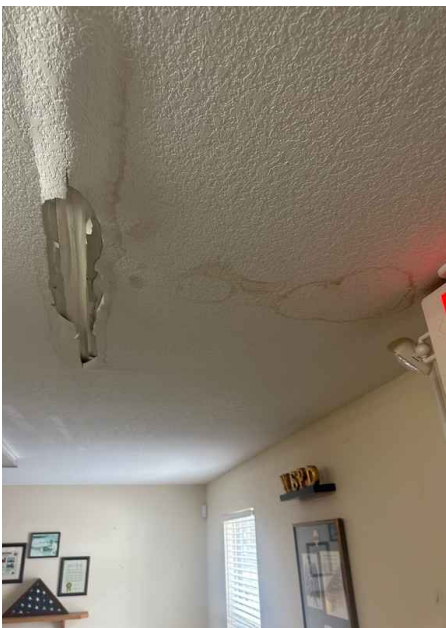
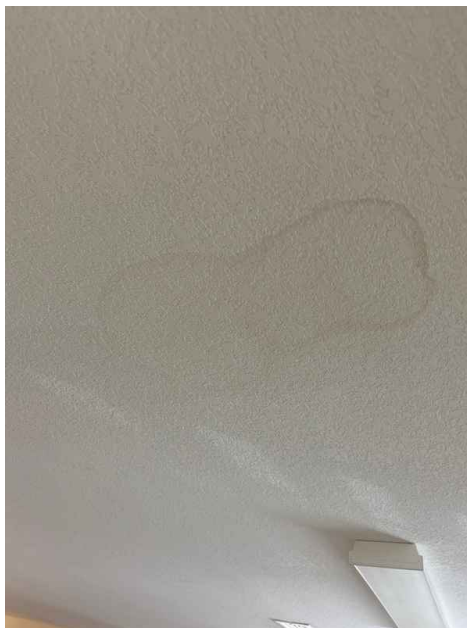
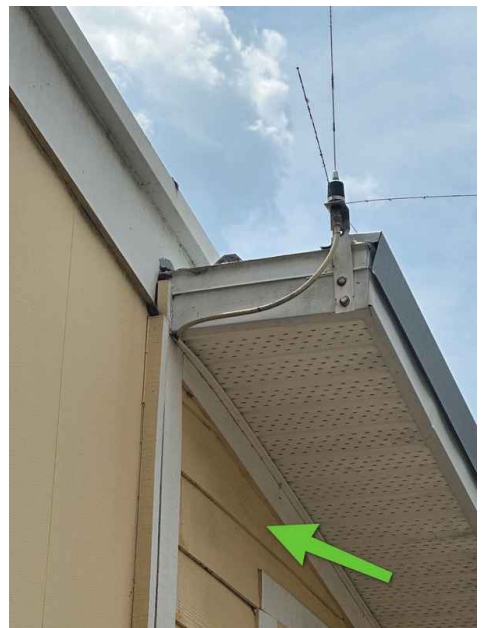
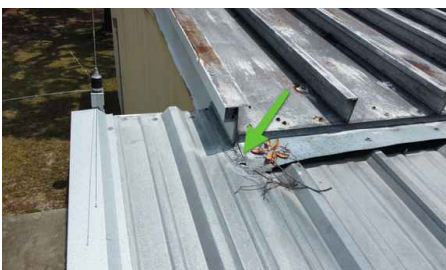
**Contributing Factors/Findings: Evidence of roof damage - active leaks noted at time of inspection**

Various locations indicated areas of moisture intrusion and roof damage. See photos for specific locations and areas observed.

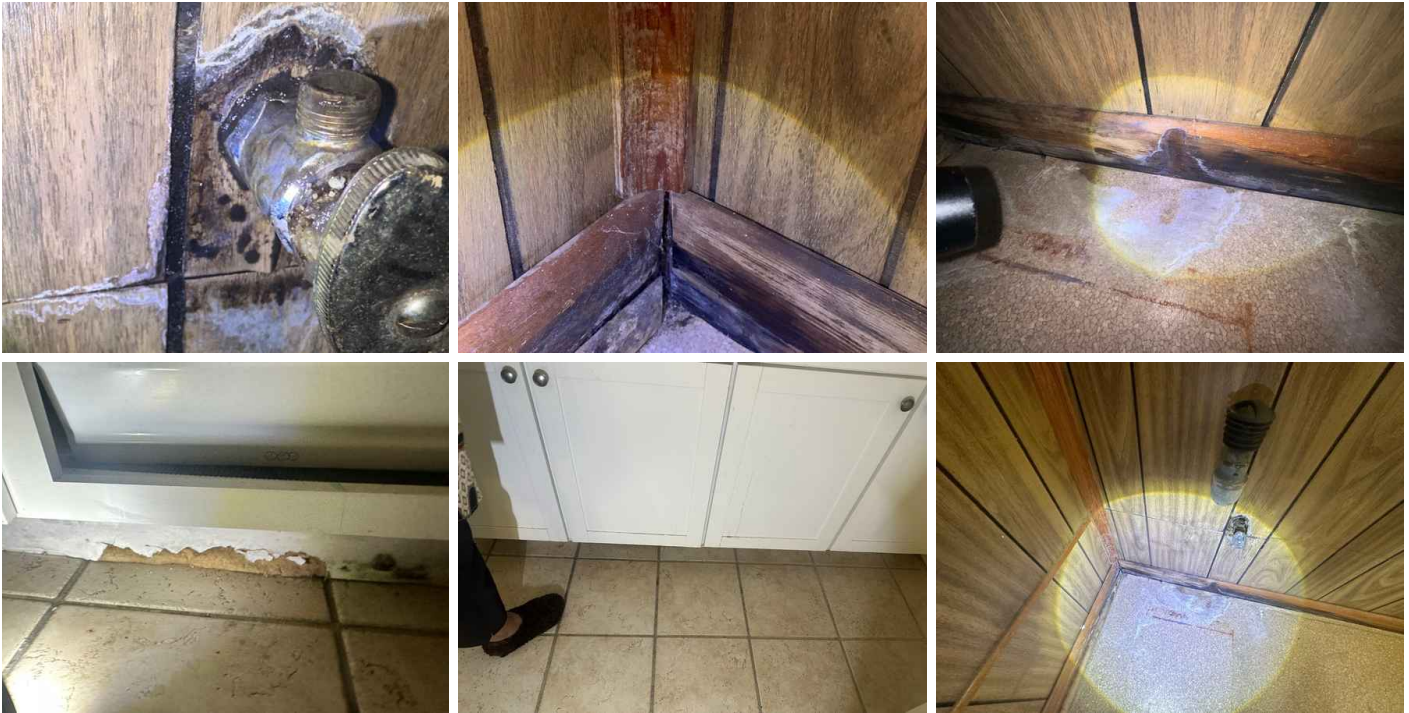
**Contributing Factors/Findings: Visible microbial/fungal growth observed**

Visible microbial/fungal growth was observed at time of assessment at areas shown in documentation photos.

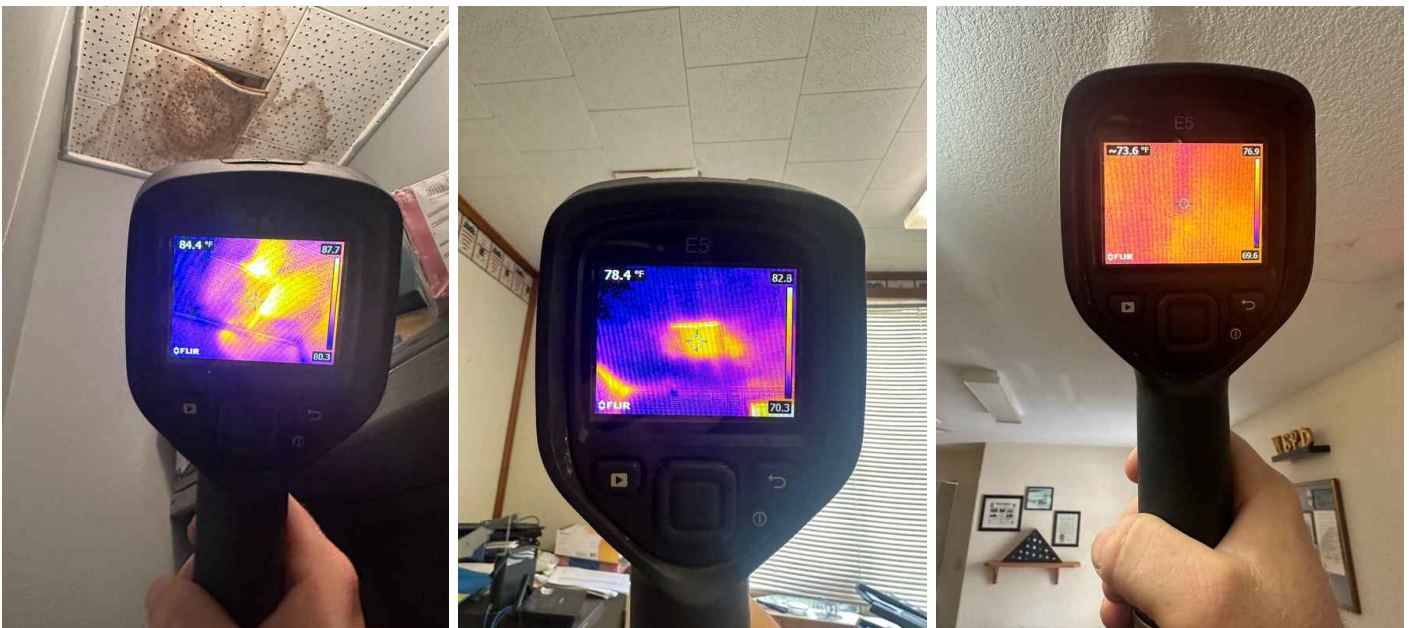
**Contributing Factors/Findings: Thermal imaging shows inconsistencies in thermal boundaries insulation**

Areas of insulation are void or missing in various areas of walls/ceilings. See photos for specific examples of areas impacted. Advise consulting with professional insulation contractor regarding necessary weatherization improvements, to minimize air transfer and thermal loss at openings and other exterior wall/ceiling coverings.

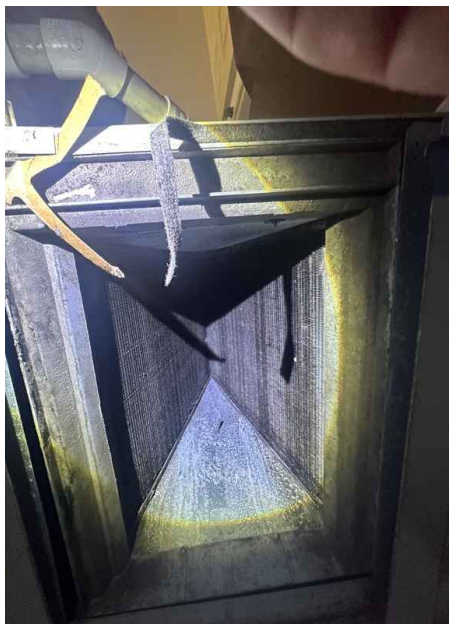
**Contributing Factors/Findings: HVAC - Air Handler - Debris build up at return chase/plenum/coils**

Utilize a professional HVAC contractor with certification in NADCA cleaning standards to perform system maintenance and cleaning on all associated ductwork system components, including ductwork and registers.

Installation of an enclosed plenum at HVAC return can also provide additional efficiency and cleanliness of the indoor air environment. Consult licensed HVAC contractor for application in your specific circumstances and system design.

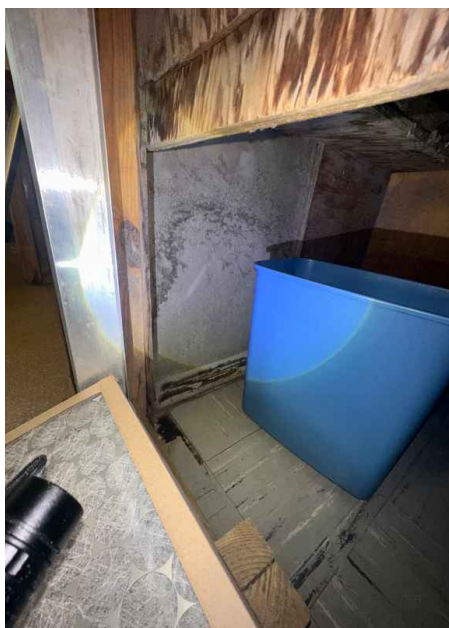
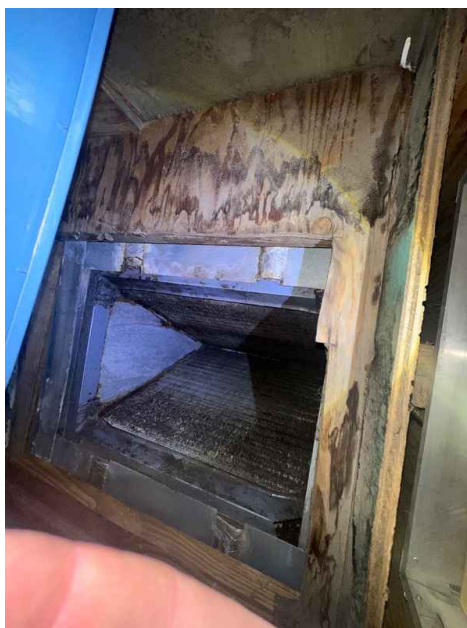
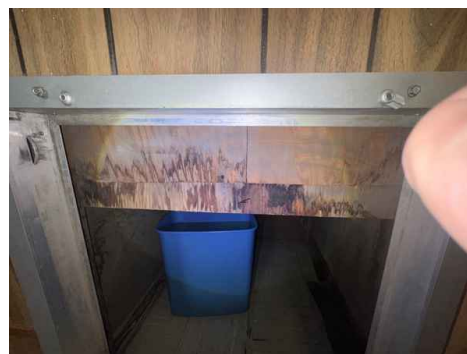
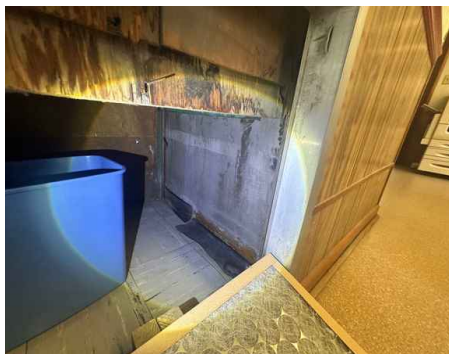
**Contributing Factors/Findings: HVAC - Package Unit - Excessive Precious Moisture (dry at time of inspection)**

Elevated humidity and thermal breaks at crawl space and exterior are producing evidence of microbial growth and conducive conditions.

Utilize a professional HVAC contractor with certification in NADCA cleaning standards to perform system maintenance and cleaning on all associated ductwork system components, including ductwork and registers.

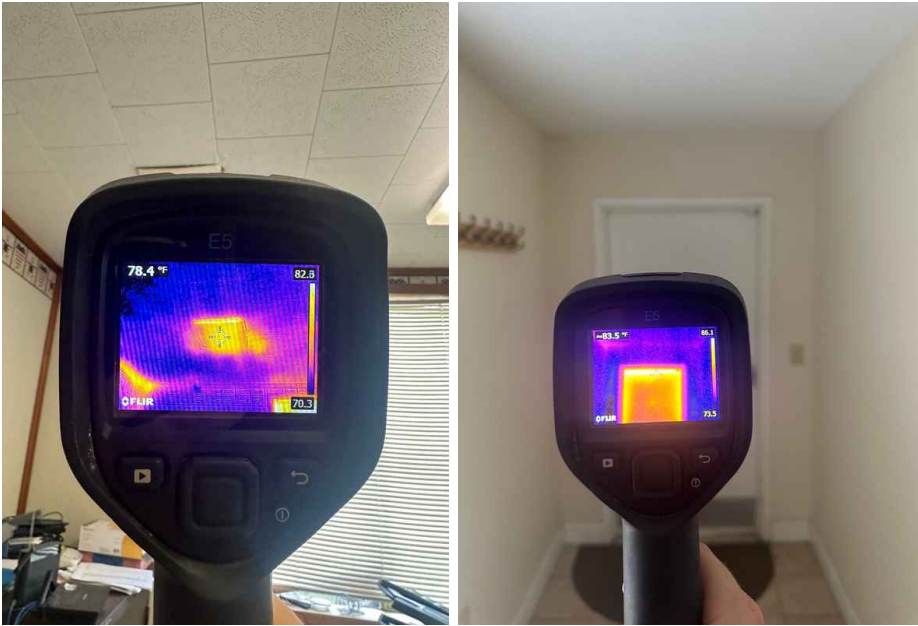
**Contributing Factors/Findings: Unsealed penetration in thermal boundary**

Unsealed penetrations through the thermal boundary will allow for air and water intrusion into undesired spaces, contributing to ideal conditions for mold growth

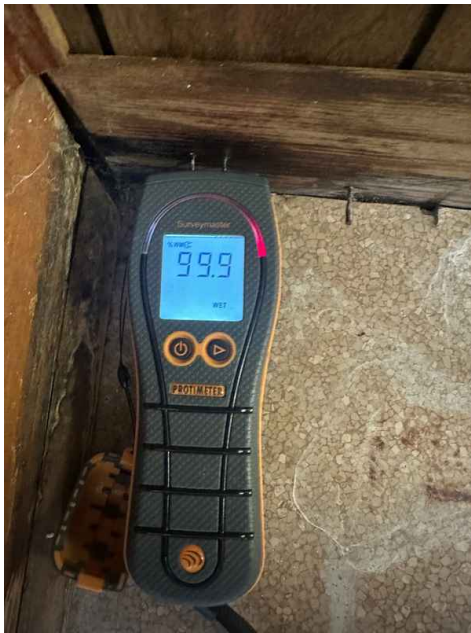
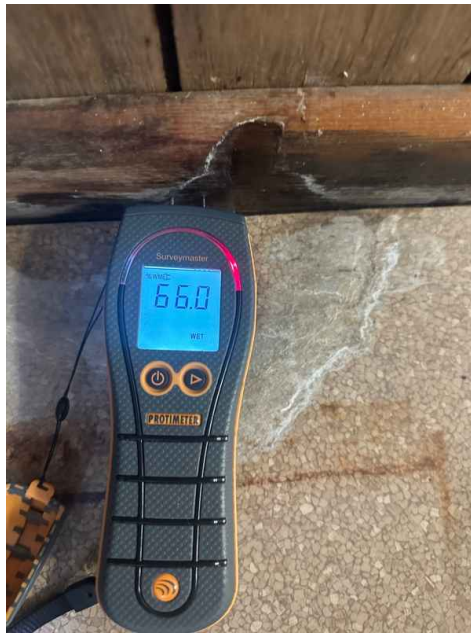
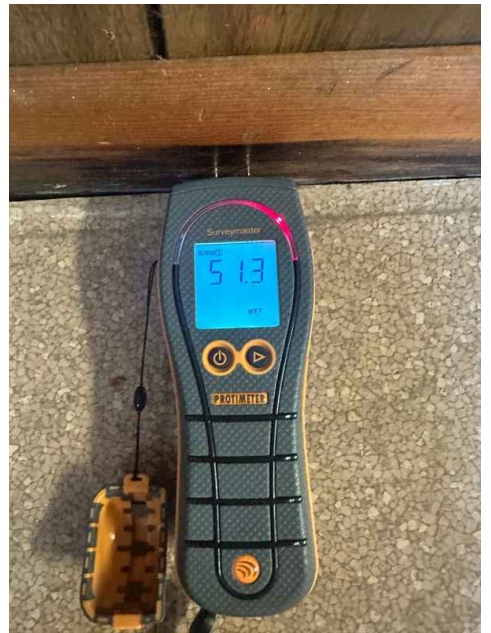
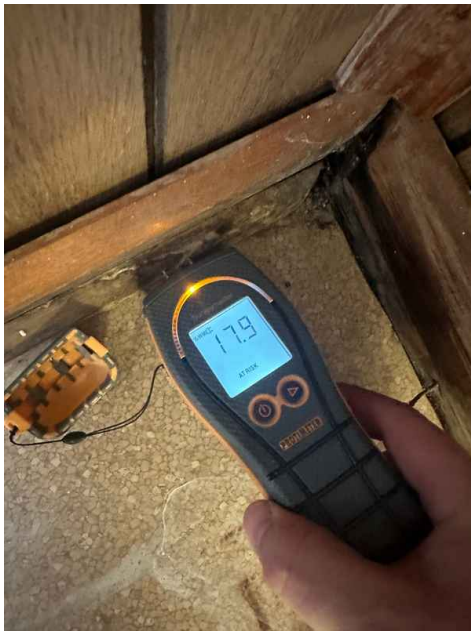
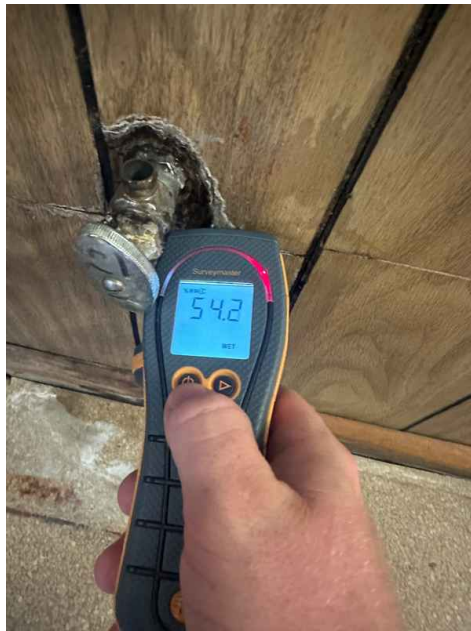
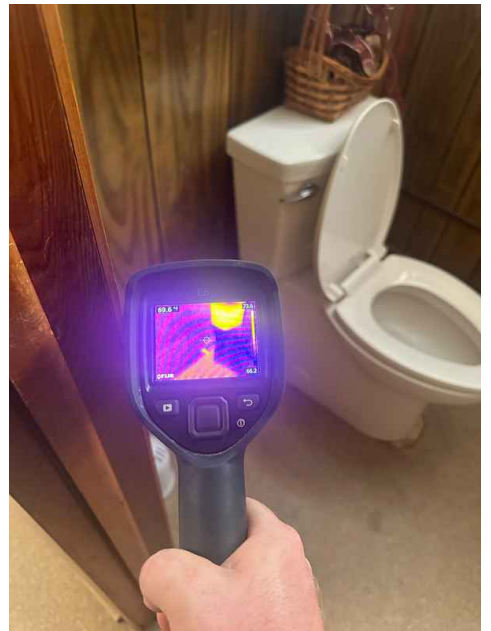
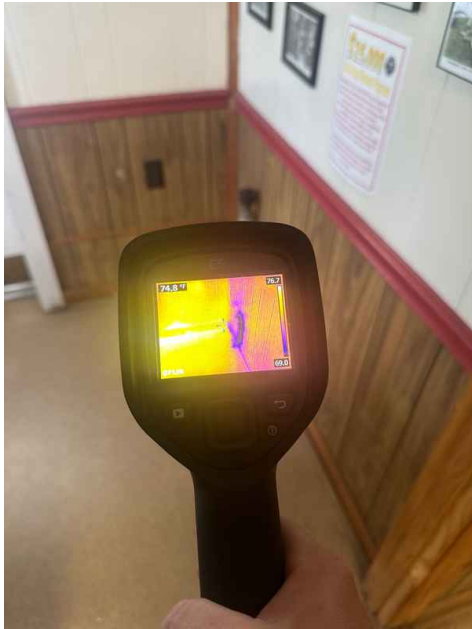
3.1.1 Contributing Factors/Findings

**EVIDENCE OF ACTIVE PLUMBING LEAK - SUPPLY LINE**

Damage to floors and surrounding wall material from leaking supply line.

Advise repair of any active leaks by licensed plumbing contractor.
